**Flood Control Project Maintenance
Levee Inspections**

Fall 2011 Levee Maintenance Deficiency Summary Report

Sacramento River Basin

**Flood Control Project Maintenance
Levee Inspections****LMA District Cover Sheet
Fall 2011 Levee Inspection Results****Reclamation District No. 0349 Sutter Island**

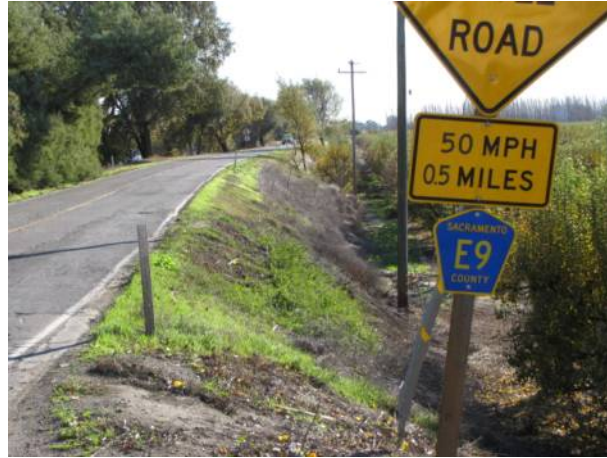
Levee Mile Report Line	1
Start Levee Mile	0.00
End Levee Mile	0.00
Location	Land Side
Category	Earthen Levee
Item	Vegetation
RD 349 Levee mile 0.00 looking downstream landward. Photo taken 11-30-2011.	
phillips_f_20111205_086.jpg

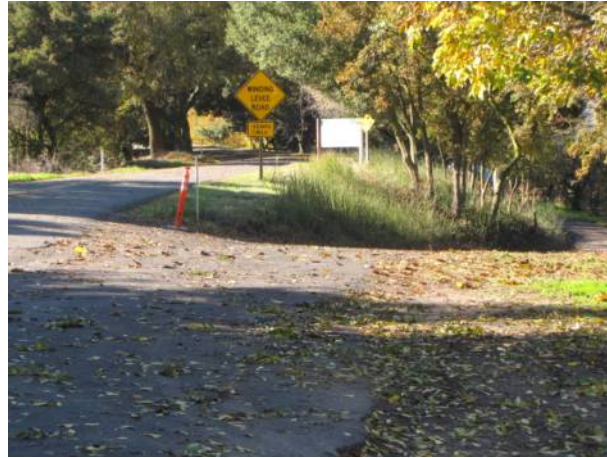
RD 349 This photo taken of levee mile 0.00 land side looking downstream of Unit 2. Photo taken 11-30-2011.

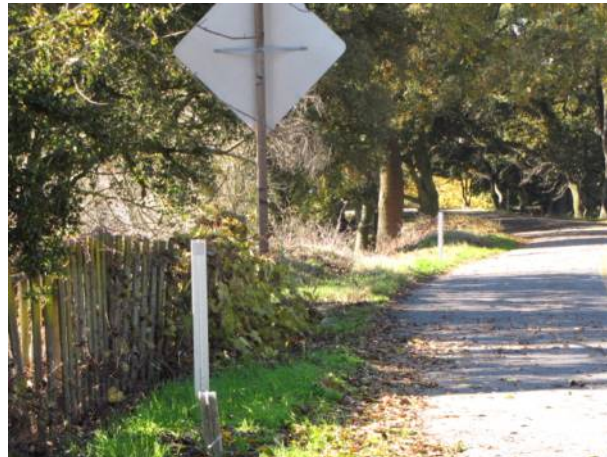
Levee Mile Report Line	2
Start Levee Mile	0.00
End Levee Mile	0.00
Location	Water Side
Category	Earthen Levee
Item	Vegetation

RD 349 Unit 2 looking downstream water side. Photo taken 11-30-2011.

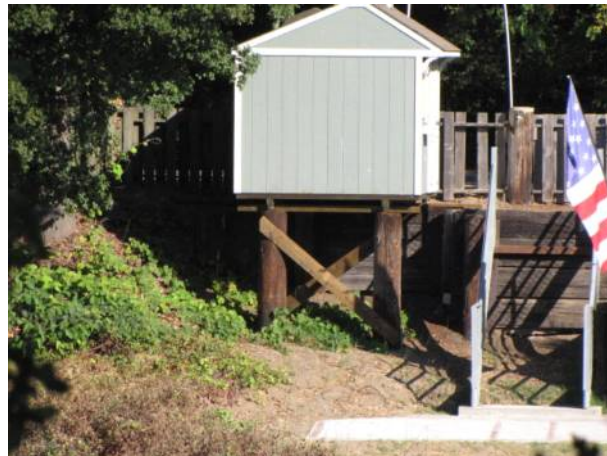
Levee Mile Report Line	3
Start Levee Mile	0.02
End Levee Mile	0.02
Location	Water Side
Category	Earthen Levee
Item	Encroachments

This is the view from across the channel of a building sitting on pilings waterside.

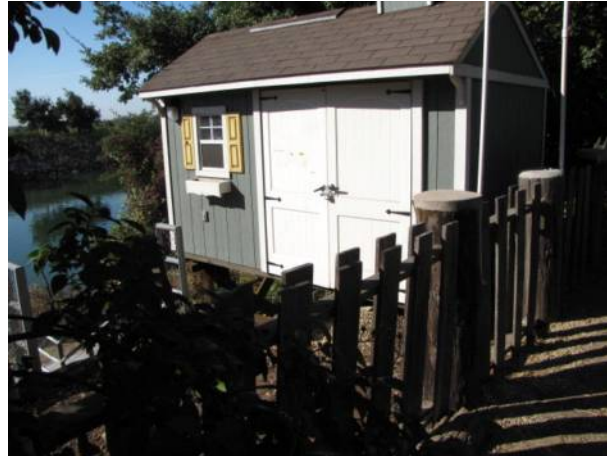
Levee Mile Report Line	3
Start Levee Mile	0.02
End Levee Mile	0.02
Location	Water Side
Category	Earthen Levee
Item	Encroachments
Unauthorized building on waterside levee mile 0.02 RD 349 Unit 2.	
phillips_f_20111109_043.jpg

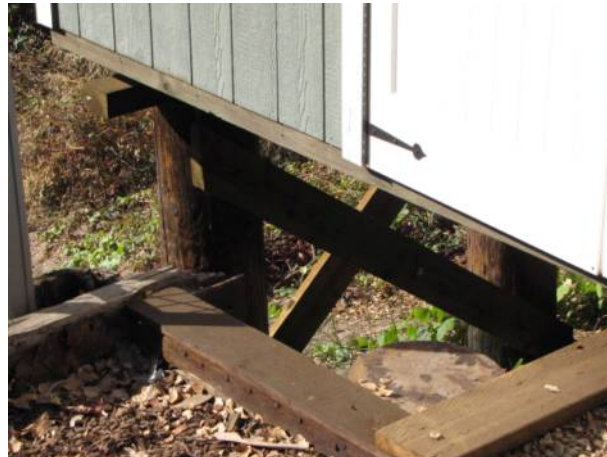
Levee Mile Report Line	3
Start Levee Mile	0.02
End Levee Mile	0.02
Location	Water Side
Category	Earthen Levee
Item	Encroachments
This photo shows the piling that the building is resting upon.	
phillips_f_20111109_044.jpg

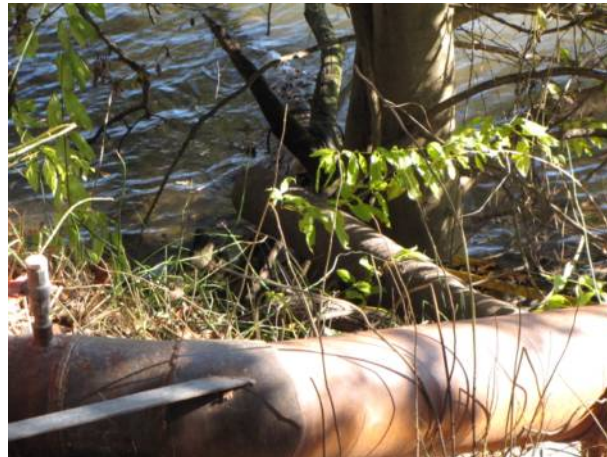
Levee Mile Report Line	26
Start Levee Mile	2.16
End Levee Mile	2.16
Location	Water Side
Category	Earthen Levee
Item	Encroachments

Discarded pipe waterward toe. Photo taken 11-30-2011.

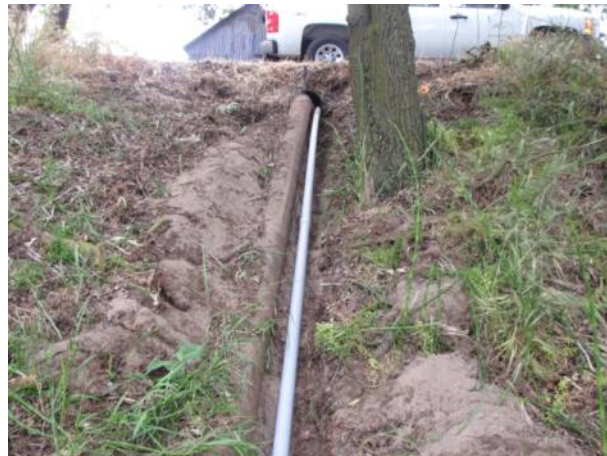
Levee Mile Report Line	27
Start Levee Mile	2.16
End Levee Mile	2.16
Location	Land Side
Category	Earthen Levee
Item	Encroachments

View from landward at unauthorized pipe installation at levee mile 2.13. Photo taken 5-23-2011

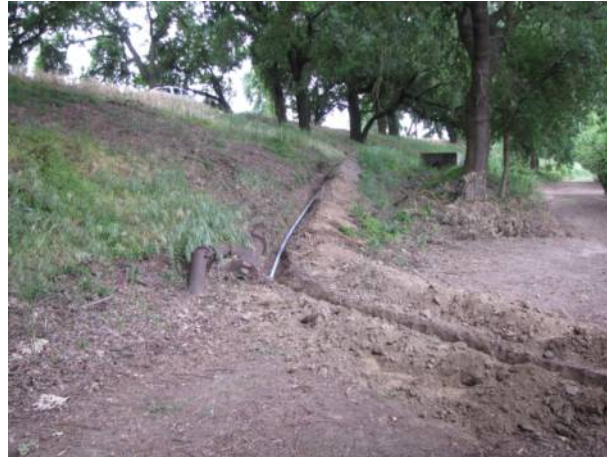
View from landside of unauthorized pipe installation. Photo taken 5-23-2011

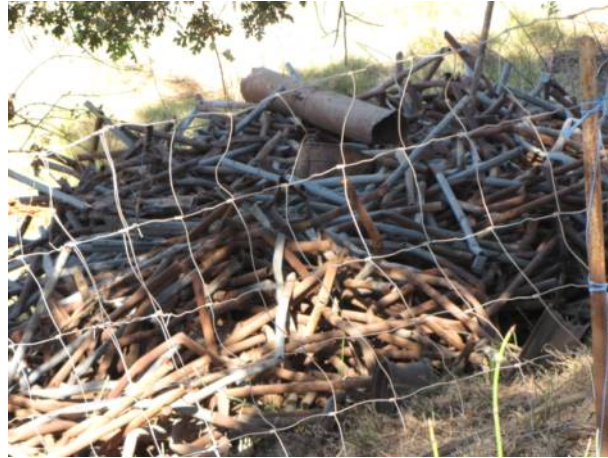
Levee Mile Report Line	35
Start Levee Mile	3.39
End Levee Mile	3.40
Location	Land Side
Category	Earthen Levee
Item	Encroachments
Old pipe stocked on land ward slope unit 2 levee mile 3.39-3.40.	
phillips_f_20111109_041.jpg

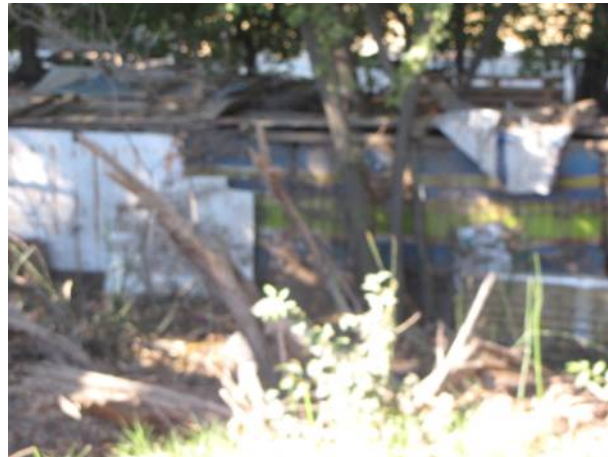
Levee Mile Report Line	41
Start Levee Mile	3.75
End Levee Mile	3.77
Location	Land Side
Category	Earthen Levee
Item	Encroachments
Building, chicken pens and goat pens at toe of levee 3.74-3.78.	
phillips_f_20111109_050.jpg

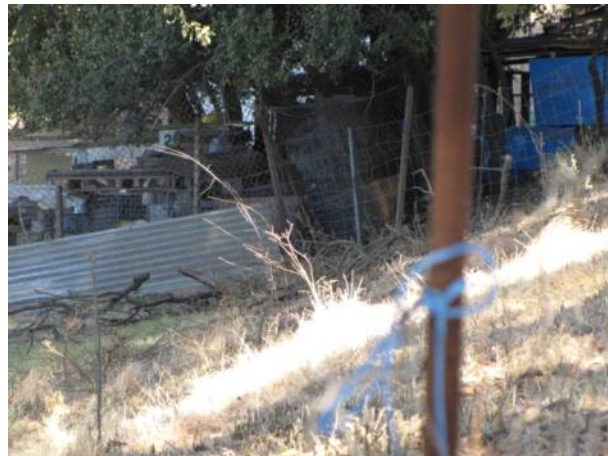
Levee Mile Report Line	41
Start Levee Mile	3.75
End Levee Mile	3.77
Location	Land Side
Category	Earthen Levee
Item	Encroachments
This photo shows a fence at right bottom and the tin in back ground is part of another pen. The top right side of photo shows the corner of a building of slope. The equipment is shown in backside of fence.	
phillips_f_20111109_051.jpg

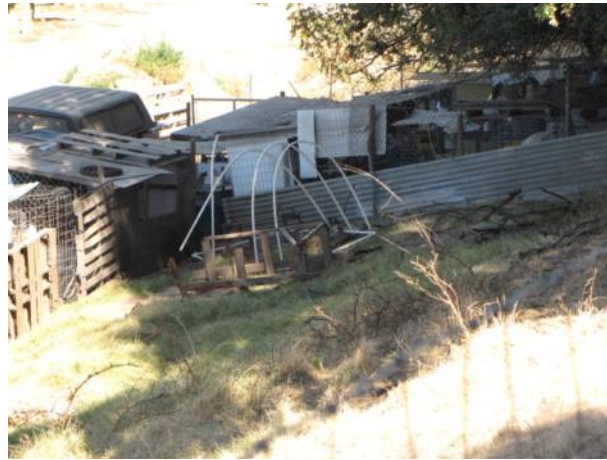
This photo shows the material on slope along with cages for goats and chickens.

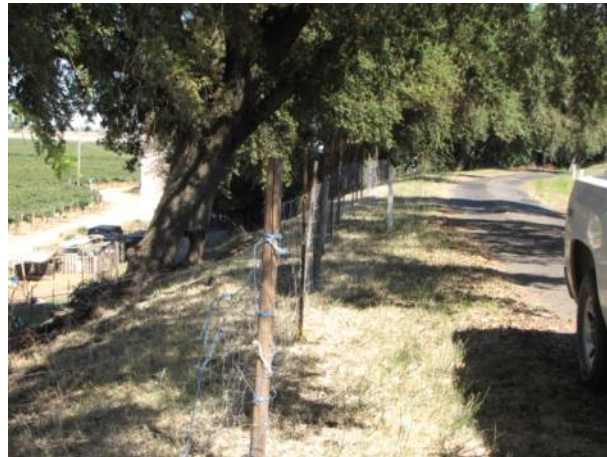
Levee Mile Report Line	43
Start Levee Mile	3.78
End Levee Mile	3.78
Location	Land Side
Category	Earthen Levee
Item	Encroachments

This fence has no permit, the landowner moves it from time to time. He keeps goats inside of it..

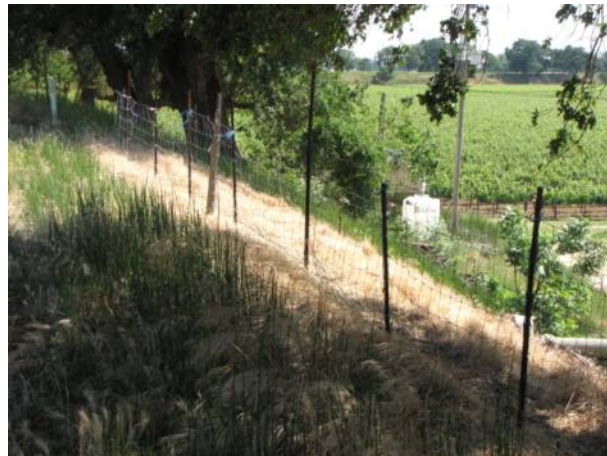
Levee Mile Report Line	44
Start Levee Mile	3.80
End Levee Mile	3.84
Location	Land Side
Category	Earthen Levee
Item	Encroachments

Unauthorized fence remains on levee slope landward levee mile 3.80-3.84. Photo taken 5-23-2011.

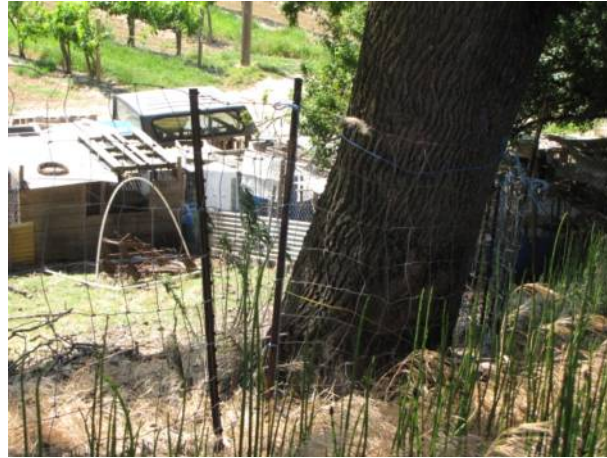
View of fence and other structures at toe of levee section. Photo taken 5-23-2011.

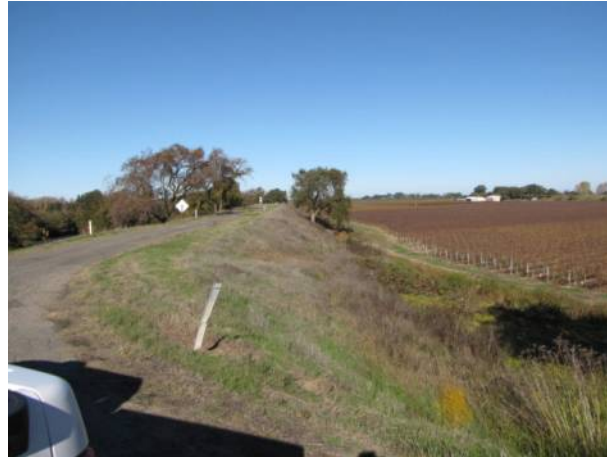
RD 349 Unit 3 looking downstream from levee mile 0.00 landward. Photo taken 11-30-2011.

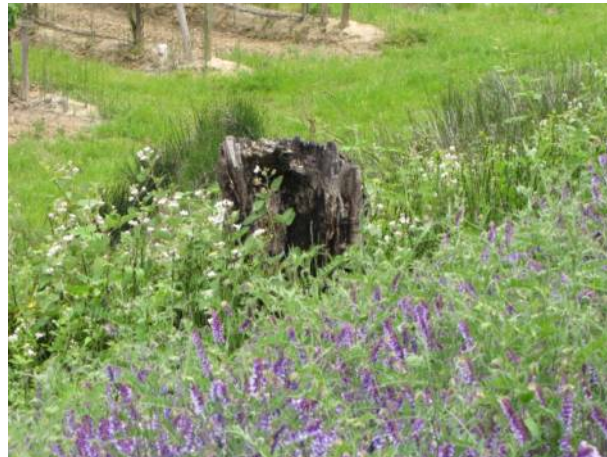
Levee Mile Report Line	7
Start Levee Mile	0.62
End Levee Mile	0.62
Location	Land Side
Category	Earthen Levee
Item	Trim / Thin Trees

This stump is located on the landward slope.

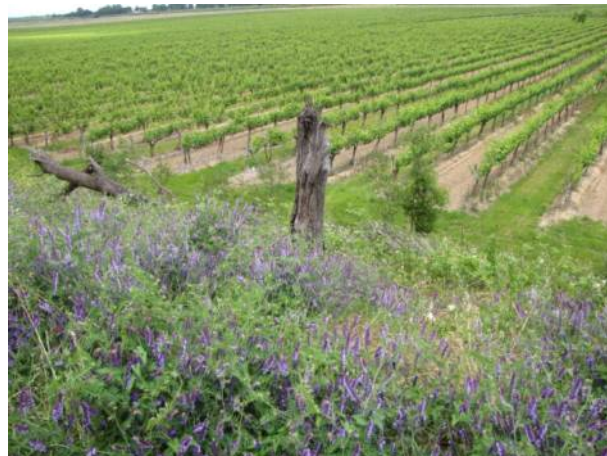
Levee Mile Report Line	8
Start Levee Mile	0.63
End Levee Mile	0.63
Location	Land Side
Category	Earthen Levee
Item	Trim / Thin Trees

Broken tree with stump on landward slope, broken top portion of this tree is resting on the landward toe. District is aware of this encroachment.

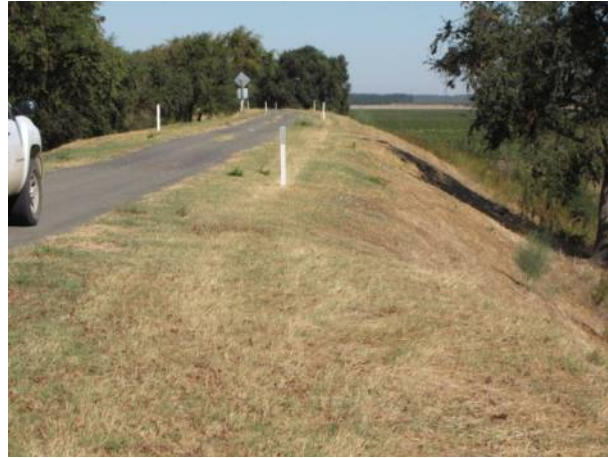
Unit 3 levee mile 0.00 land side looking down stream.

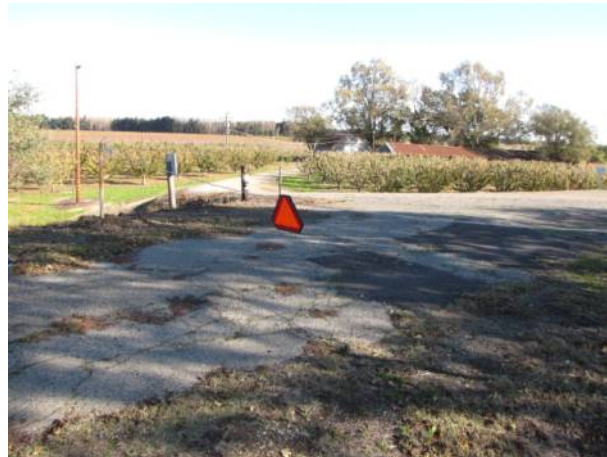
Levee Mile Report Line	24
Start Levee Mile	4.07
End Levee Mile	4.07
Location	Crown
Category	Earthen Levee
Item	Encroachments

Unauthorized cable crossing the levee crown roadway, levee mile 4.07. Photo taken 11-30-2011.

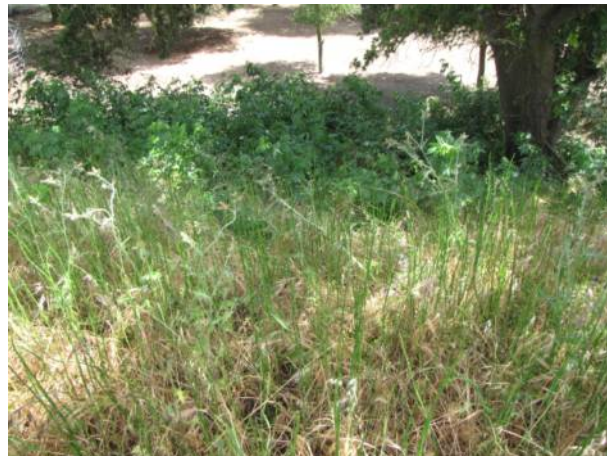
Levee Mile Report Line	27
Start Levee Mile	5.13
End Levee Mile	5.31
Location	Land Side
Category	Earthen Levee
Item	Vegetation

Wild growth on landward slope and toe of levee section. Photo taken 5-23-2011

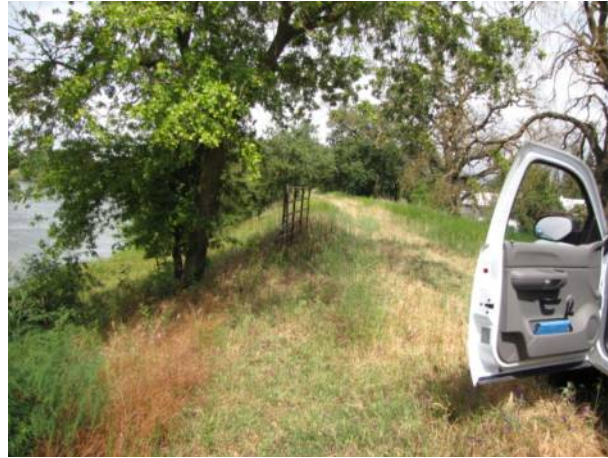
Another view of wild growth on levee section looking downstream. Photo taken 5-23-2011.

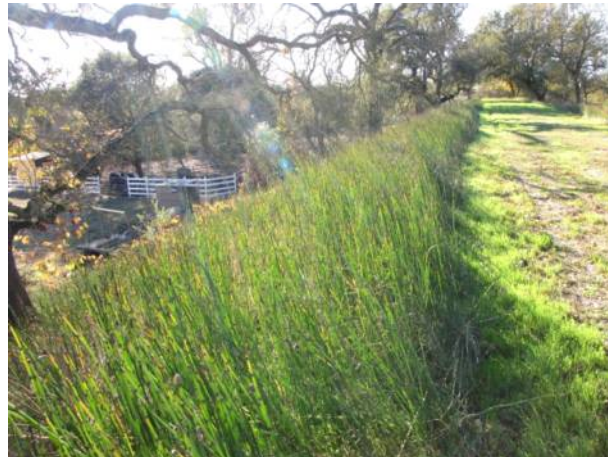
Levee Mile Report Line	30
Start Levee Mile	5.40
End Levee Mile	5.40
Location	Land Side
Category	Earthen Levee
Item	Vegetation

RD 349 Unit 3 unsatisfactory growth on landside looking upstream landward. Photo taken 11-30-2011.

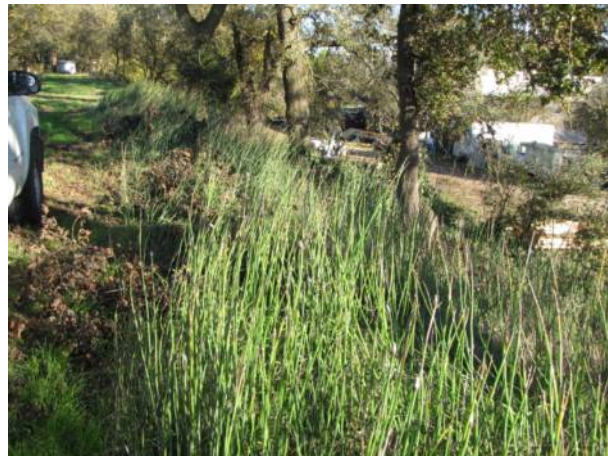
Levee Mile Report Line	30
Start Levee Mile	5.40
End Levee Mile	5.40
Location	Land Side
Category	Earthen Levee
Item	Vegetation

Unsatisfactory growth on landward slope looking downstream landward. Photo taken 11-30-2011.

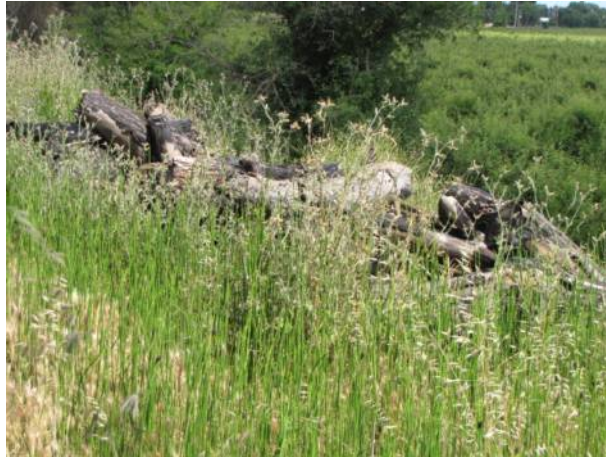
Levee Mile Report Line	31
Start Levee Mile	5.71
End Levee Mile	5.74
Location	Land Side
Category	Earthen Levee
Item	Encroachments
Firewood on levee slope not removed from fall inspection 2010. Photo taken 5-23-2011	
phillips_f_20111109_061.jpg
